CRANE and RIGGING CO.

## SERVICE REPORT

Equipment # 300388

M/M/T: Manitowoc 2250

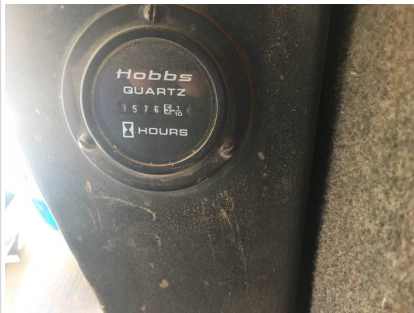
PM Type	500 Hr
	  35.835594, -98.264449
Repairs Completed:	Change oil and all filters listed
Photos of New Filter w/Date	 
	01-09-2019 10:35 AM
