VIN: 3HSDJSJR3EN057242

## 2014 INTERNATIONAL PROSTAR

### Inspection Photos

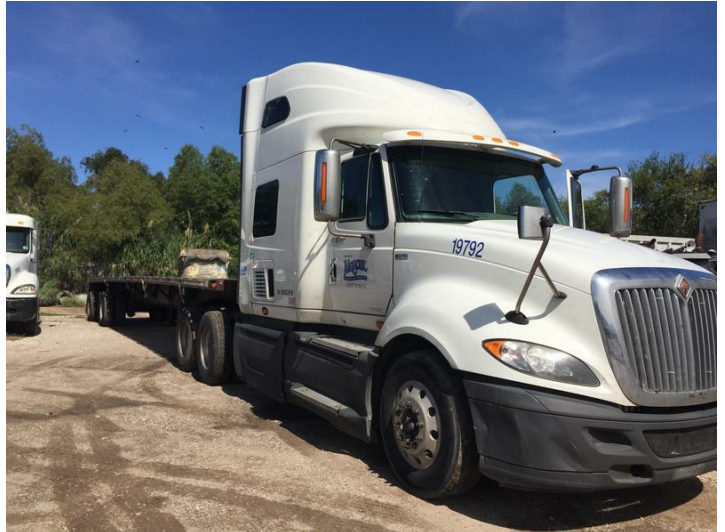
Wear and Tear Items	
Diagnostics	Active faults: 647-3   Inactive faults: 111-1, 1810-15, 94-0, 789-1, 1059-2
Bumper	Right side of plastic bumper is pushed in
Tires	6 below terms
Sleeper	Top mattress missing
Headache rack	Damaged at rear
Power steering	Appears to be leaking at gear box
Paint	Var
Interior	Soiled
