### SERVICE REPORT

M/M/T: Grove RT890E

Equipment # BE9085

Serial # 234114

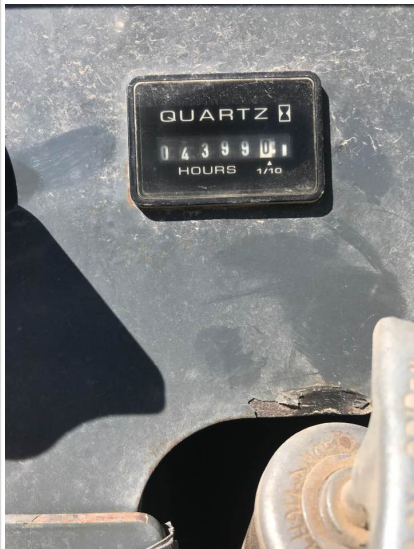
PM Type	500 Hr

42.405211, -95.497008
Repairs Completed:	Yes
Photos of New Filter w/Date
